Short Block Modifications - 43 and 48 Cubic Inch Engines

INGERSOLL PARTS BULLETIN

TOPIC: PREMATURE FAILURE OF ONAN CONDENSER --
PART NO. C 23855

SUBJECT: Vapor Lock Symptoms - Models 226, 446, 448 Tractor and
648 Loaders with Onan Engines

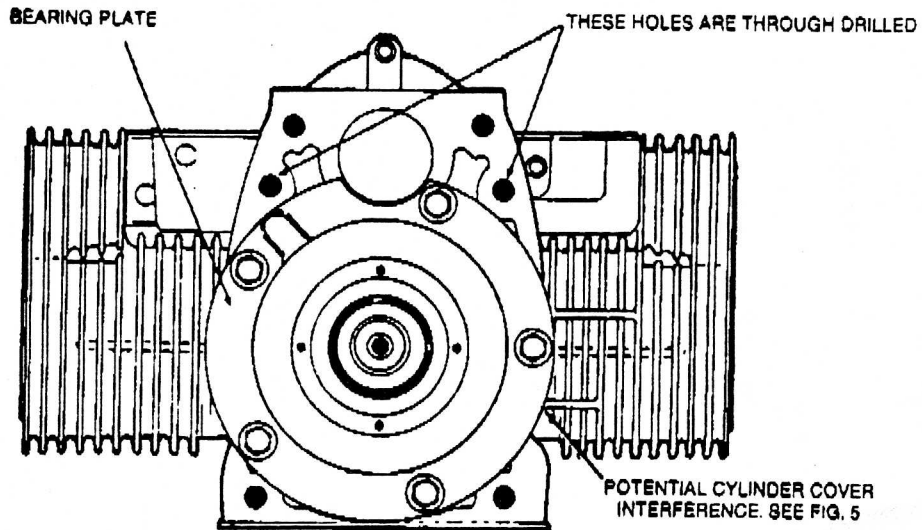
FIGURE 2. ENGINE BLOCK HOLES

The two engine block holes above the bearing plate (Figure 2) are through drilled and must be plugged if not used in your application.

Oil leakage resulting from inadequately plugging holes may cause serious personal injury or permanent engine damage. Follow required procedure to plug holes.

Apply thread sealer to a 3/8" -16 x 5/8" Allen set screw or a 3/8" -16 x 1/2" cap screw with a 3/8" copper flat washer and install in engine block holes.

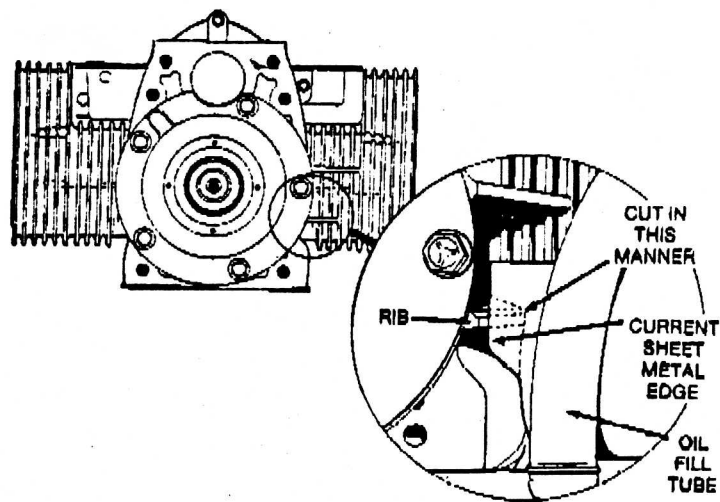
FIGURE 5. CYLINDER AIR HOUSING

The left side cylinder air housing may interfere with a rib that has been added to the block casting. See Figure 5. Extend the radiused corner up to clear the rib. Again, avoid cutting sharp notches and smooth the rough surface.

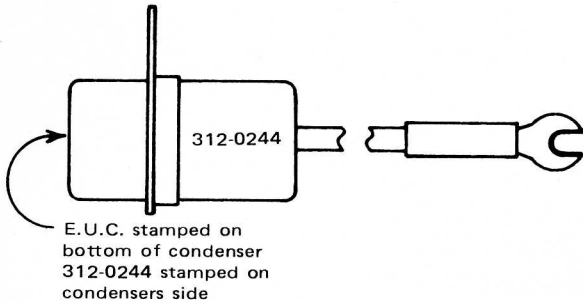
FIGURE 1. (A) **WRONG**

- 1] Some C 23855 condensers manufactured by E.U.C. (identified by E.U.C. stamped on the bottom and 321-0244 stamped on the side of the condenser) can have an improperly soldered condenser lead. (See FIGURE 1. (A).
- 2] Some C 23855 condensers manufactured by Phelon (identified by 312-0246 stamped on the bottom) can breakdown in applications when condenser temperature exceeds manufacturer's guidelines. See FIGURE 1. (B).

To eliminate potential field problems with these condensers, upon receipt of this bulletin, initiate the following action:

- 1] Remove all C 23855 condensers from your stock and from C 23853 ignition assemblies in your stock.
- 2] Submit a properly completed Service Adjustment Request for the quantity of C 23855 condensers you have removed from your stock to:
