Short Block Modifications - 43 and 48 Cubic Inch Engines

INGERSOLL PARTS BULLETIN

TOPIC: PREMATURE FAILURE OF ONAN CONDENSER --
PART NO. C 23855

SUBJECT: Vapor Lock Symptoms - Models 226, 446, 448 Tractor and
648 Loaders with Onan Engines

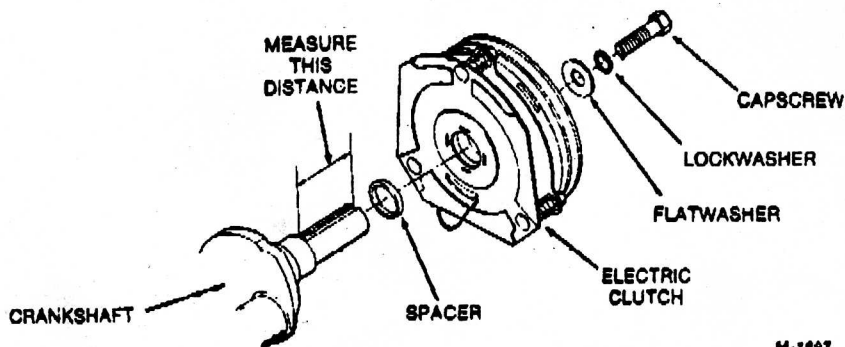
FIGURE 1. PTO SPACER

When replacing an engine that has a crankshaft of 1-7/16" diameter and a stub end length of 3-1/16" (measure stub end length, Figure 1), the supplied crankshaft spacer must be installed as shown in Figure 1. If replacing an engine with a stub end length of 2-5/8", do not use the spacer. If installing an electric clutch on the crankshaft, the air gap must be adjusted. Refer to the equipment manufacturer's service manual for the proper adjustment procedure.

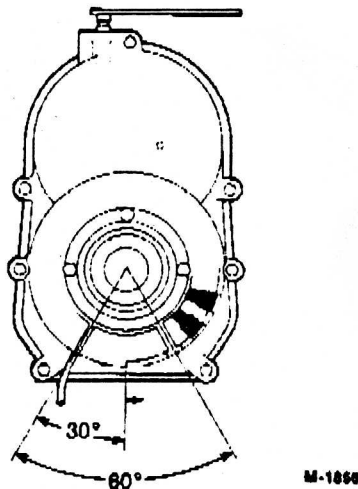
FIGURE 3. STATOR LEAD ORIENTATION

Assemble the stator to the replacement Gearcase cover with the lead connection within the lower 60 degree area as shown in Figure 3.

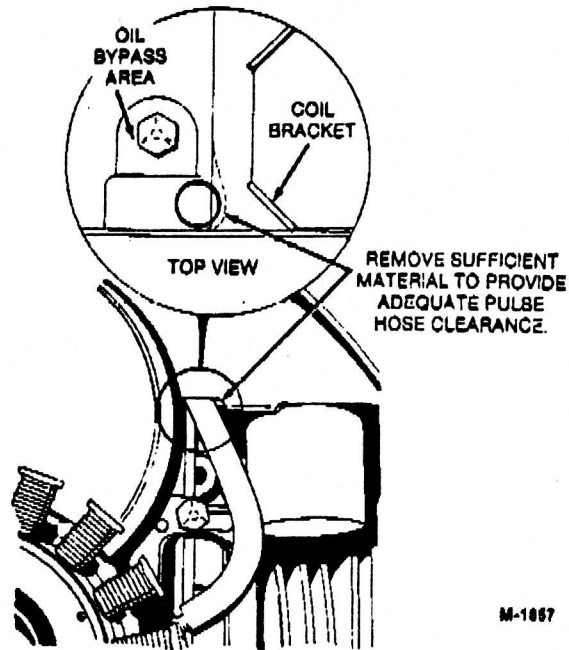
FIGURE 4. PULSE PICK-UP HOSE

Some modifications may be required to allow your sheet metal to be used with the new spec short block. Some short blocks are equipped with the pulse pick-up hose on the gearcase assembly which must be routed to the pulse fitting on the carburetor. Cut out sufficient material in the corner where the front blower housing meets the coil bracket to allow the hose to be routed along the gearcase cover and over the oil bypass area to the carburetor without being pinched. See Figure 4. Avoid cutting sharp notches in the sheet metal to prevent cracking and smooth the rough edges to avoid cutting or damaging the hose during use.

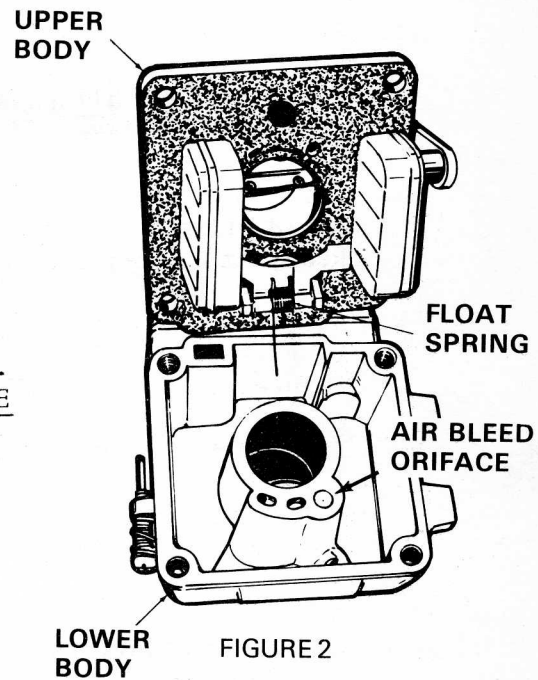
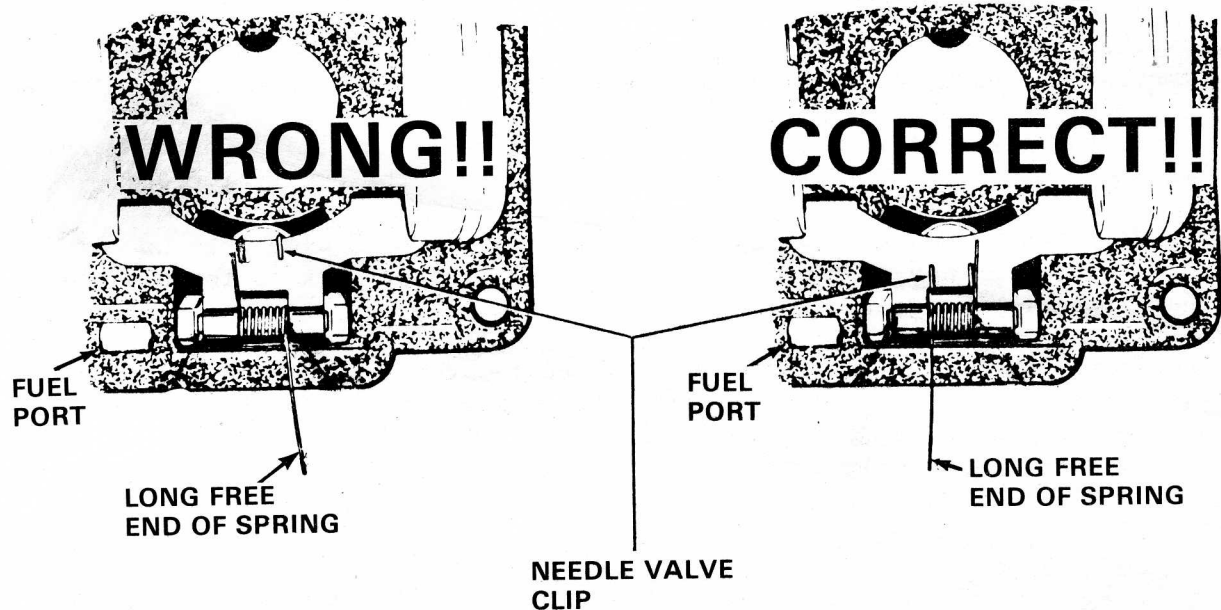
6. Install the gasket.
7. Install the float as show in the illustration. MAKE CERTAIN THE FLOAT SPRING AND NEEDLE VALVE CLIP ARE INSTALLED AS SHOWN IN THE CORRECT ILLUSTRATION.

8. Reinstall the needle valve clip so it hooks over the float from the hinge pin side.
9. Reinstall the float spring with the long free end pointing away from the float and on the side closest to the fuel inlet passage. Correctly reinstalled the float spring will be "unwinding" as the float sinks. When installed incorrectly the spring tension will prevent the float from providing the proper fuel level.

10. Set the float level between 3/32" and 1/8" between the gasket and float body (not float seam) with the gasket installed. Use a 3/32" drill bit as a "feeler" gauge to help set the float. Insure that both halves of the float are even with each other.
